**UNDERGROUND STORAGE TANK CLOSURE  
FLOWERS STORE ON NC HIGHWAY 42 EAST  
CLAYTON, NORTH CAROLINA**

**By  
Froehling & Robertson, Inc.  
Raleigh, North Carolina**

Re: Underground Storage Tank Closure  
Flowers Store on N.C. 42 East  
Clayton, North Carolina

#### FIGURE 3 MONITORING WELL LOCATION MAP

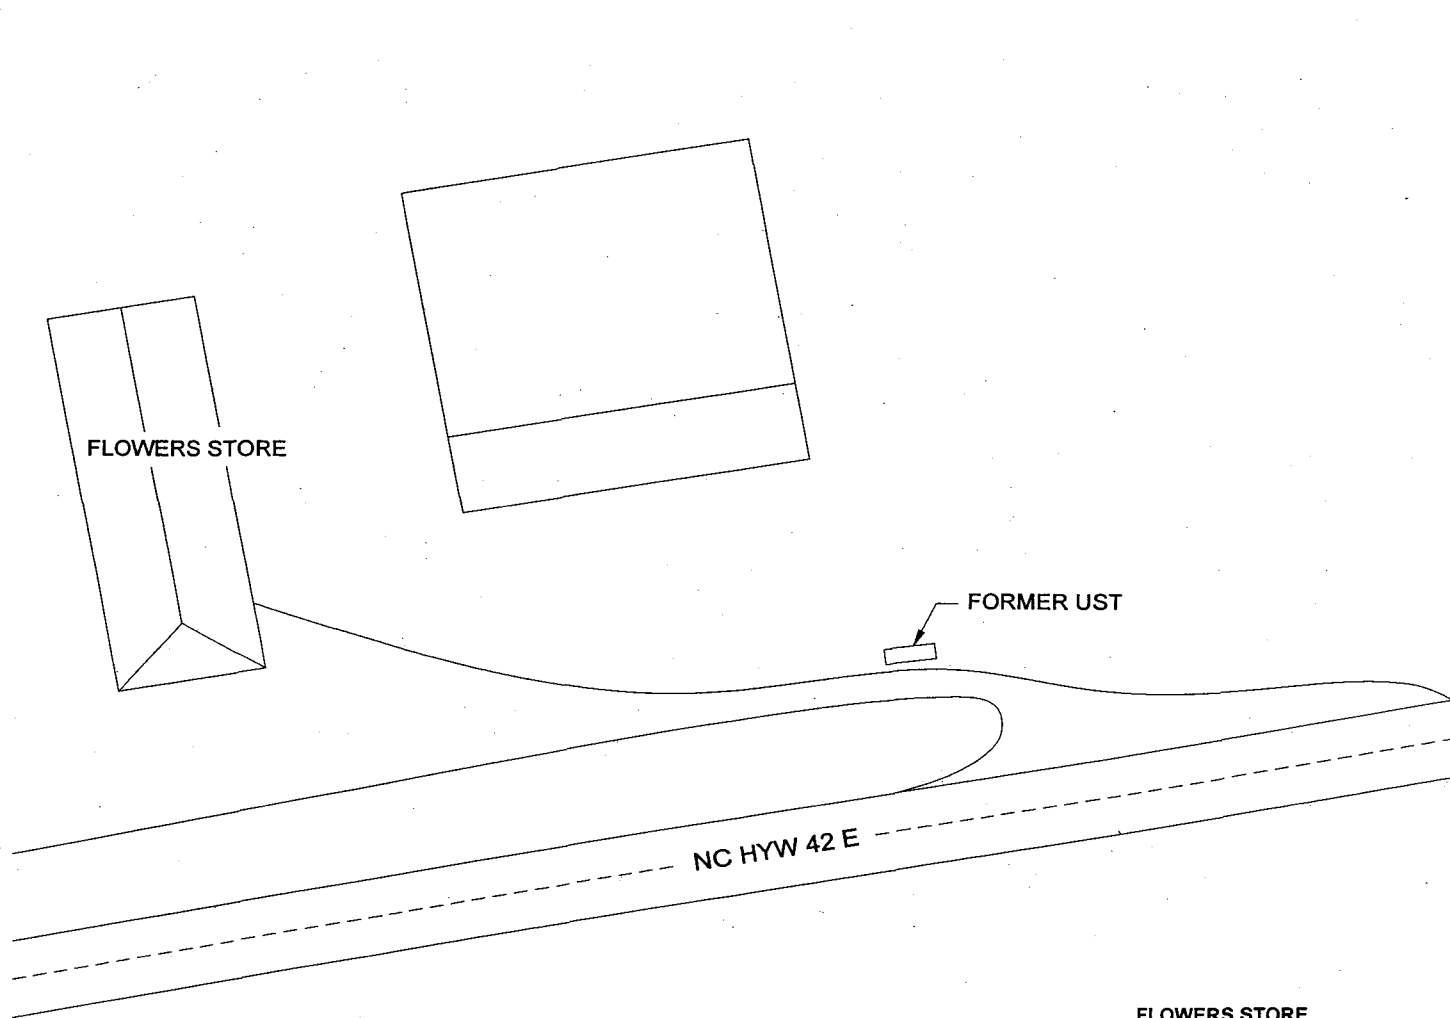
Project No.: 17217	Drawing No.: 0519060101	Project Title: Figure 2 Site Diagram FLOWERS STORE CLAYTON, NORTH CAROLINA	<b>AGRA ENVIRONMENTAL</b> Cary, North Carolina
Checked By: RBS	Scale: 1" = 50'		
Drawn By: MAC	Date: 5/19/06

**FLOWERS STORE  
UST INFORMATION**

TANK ID	CAPACITY (GALLONS)	DATE INSTALLED	DATE REMOVED	PRODUCT	STATUS
1	1,000	UNKNOWN	4/24/2006	Gasoline	P
STATUS: C = CURRENTLY IN USE P = PERMANENTLY CLOSED BY REMOVAL

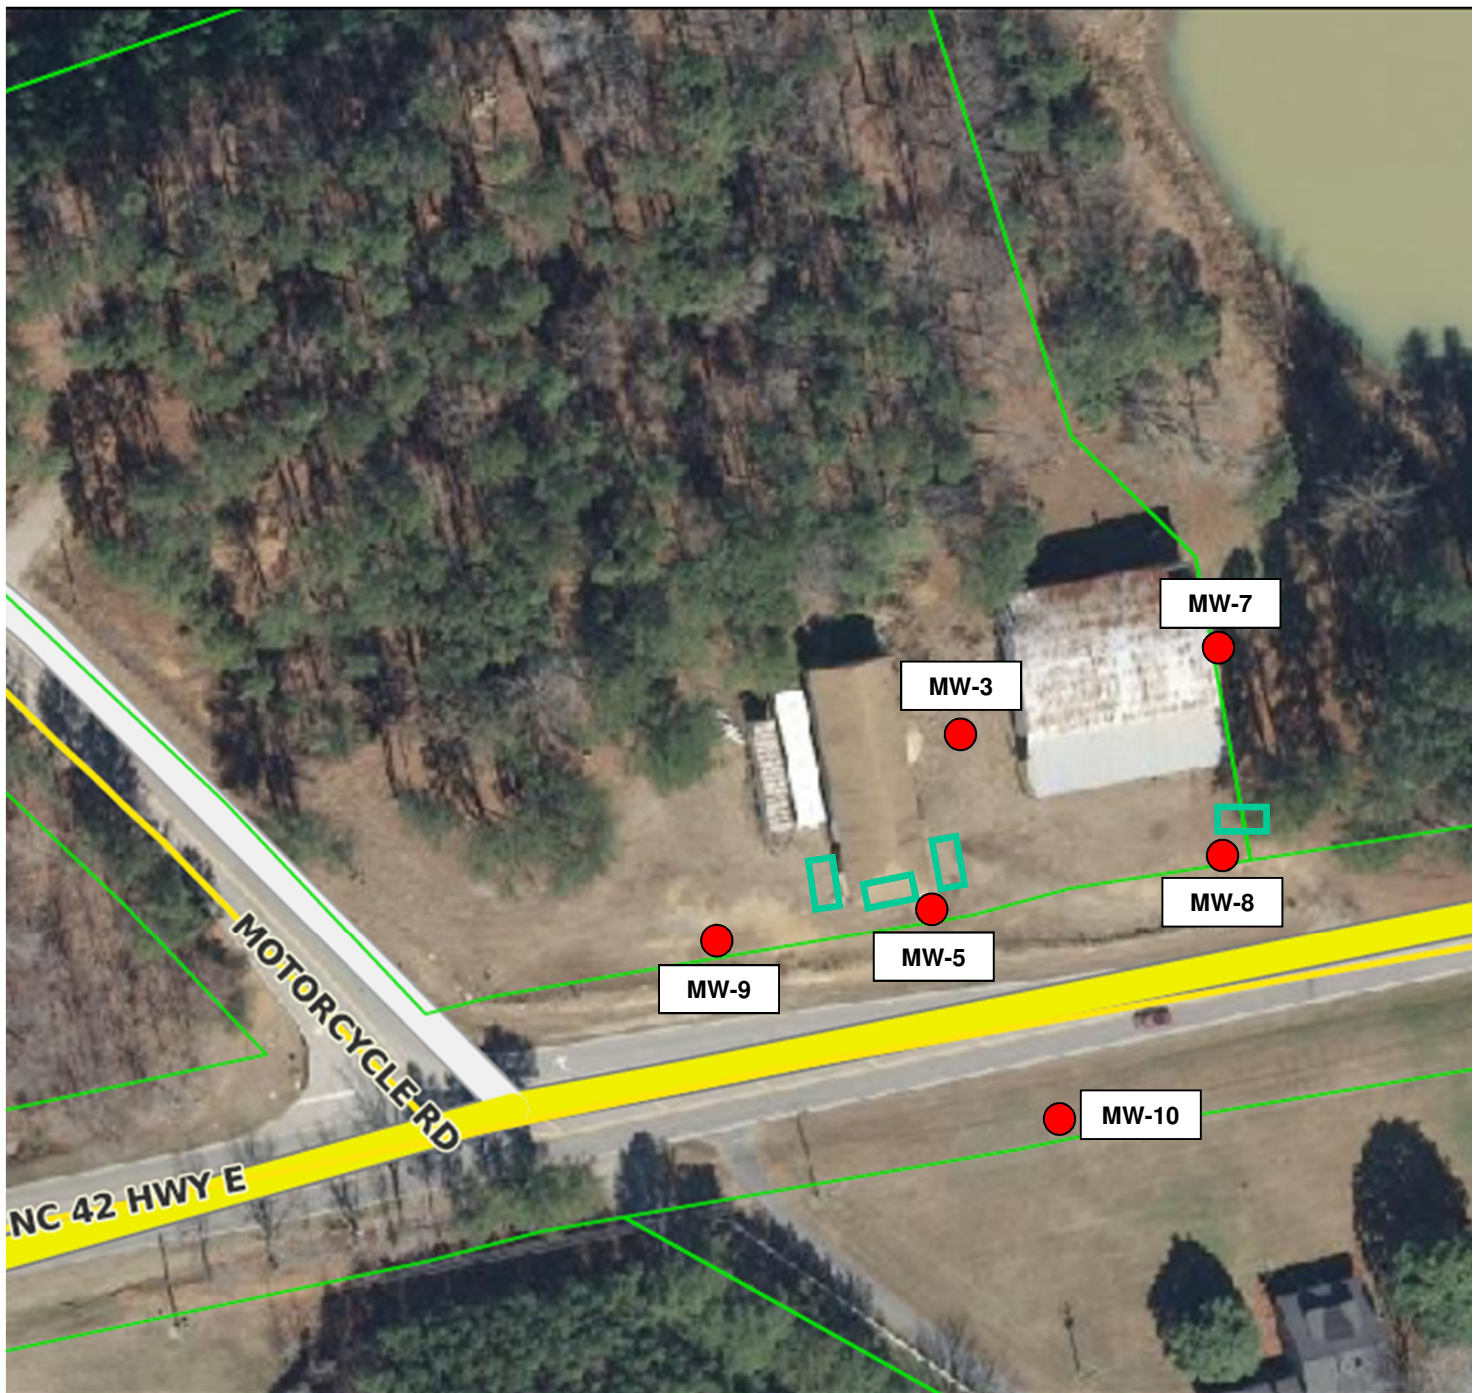
MW-3 ● Approximate Location of Monitoring Well

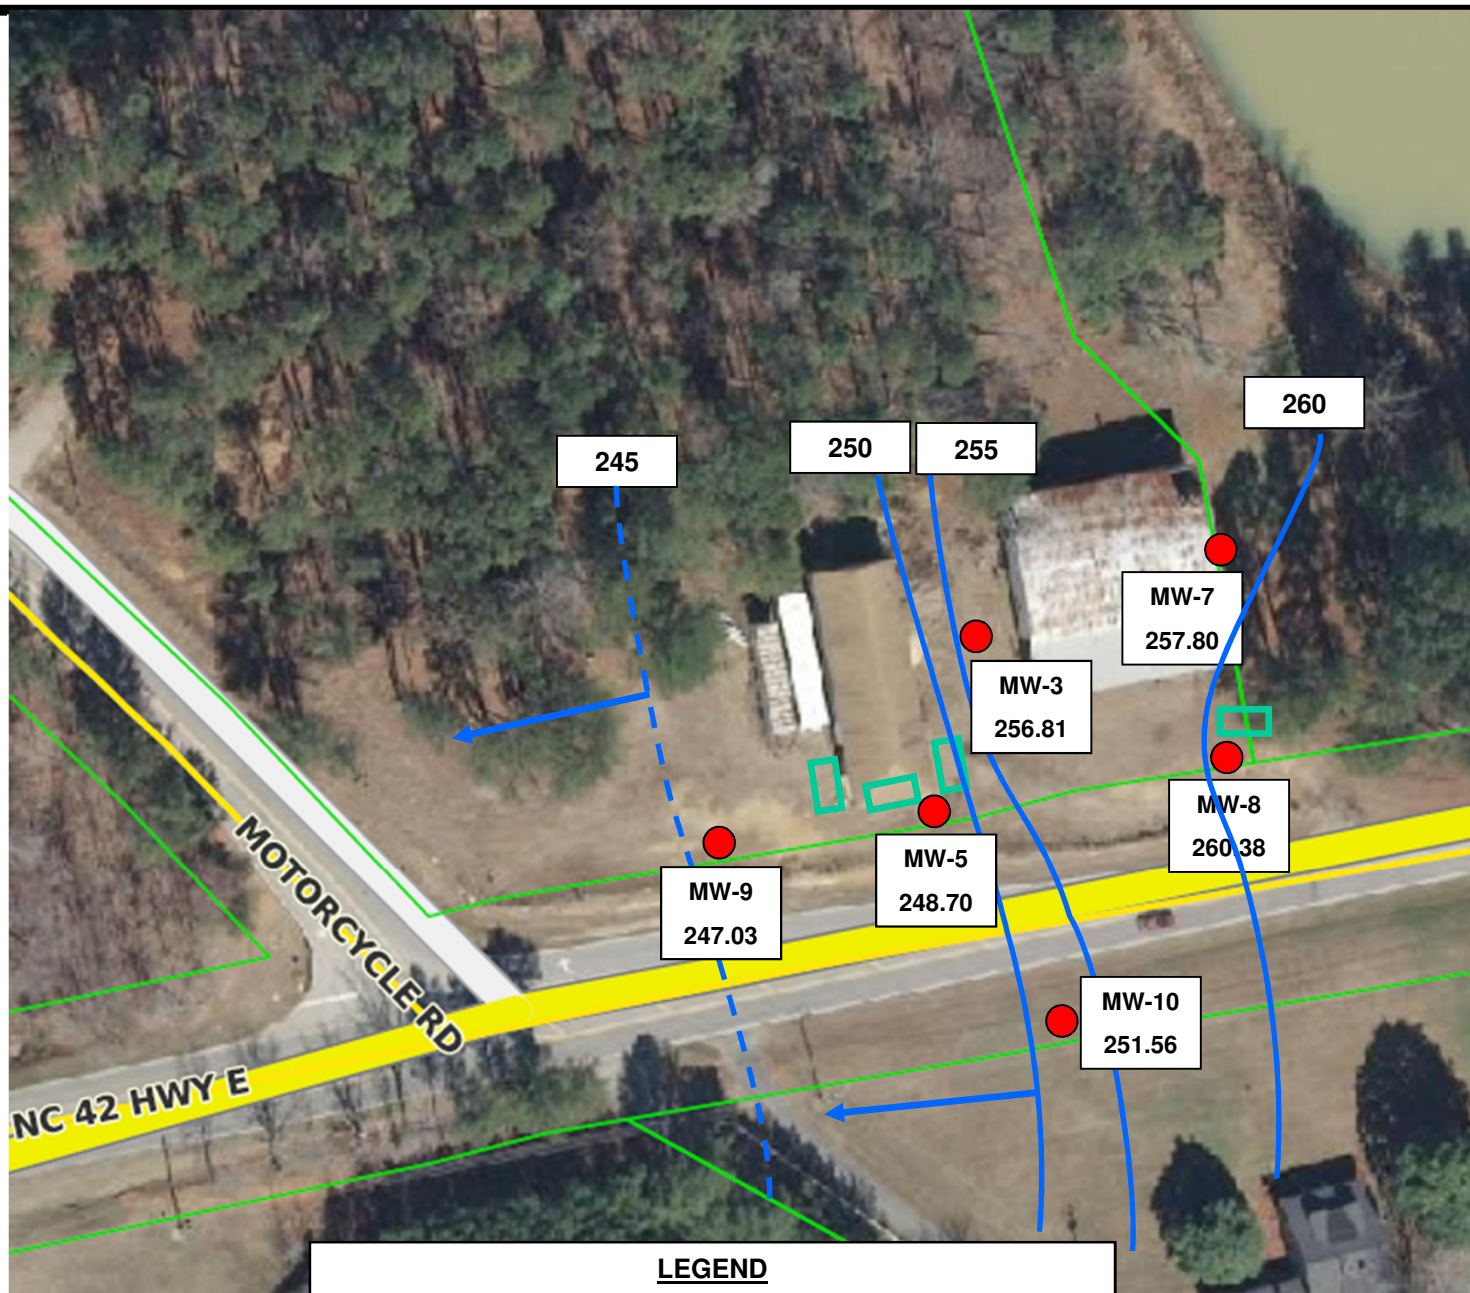
#### FIGURE 4 GROUNDWATER ELEVATION MAP

- MW-3** ● Approximate Location of Monitoring Well
- 256.32 Groundwater Elevation
- Groundwater Contour Line
- - - Estimated Groundwater Contour Line
- ➔ Estimated Direction of Groundwater Flow

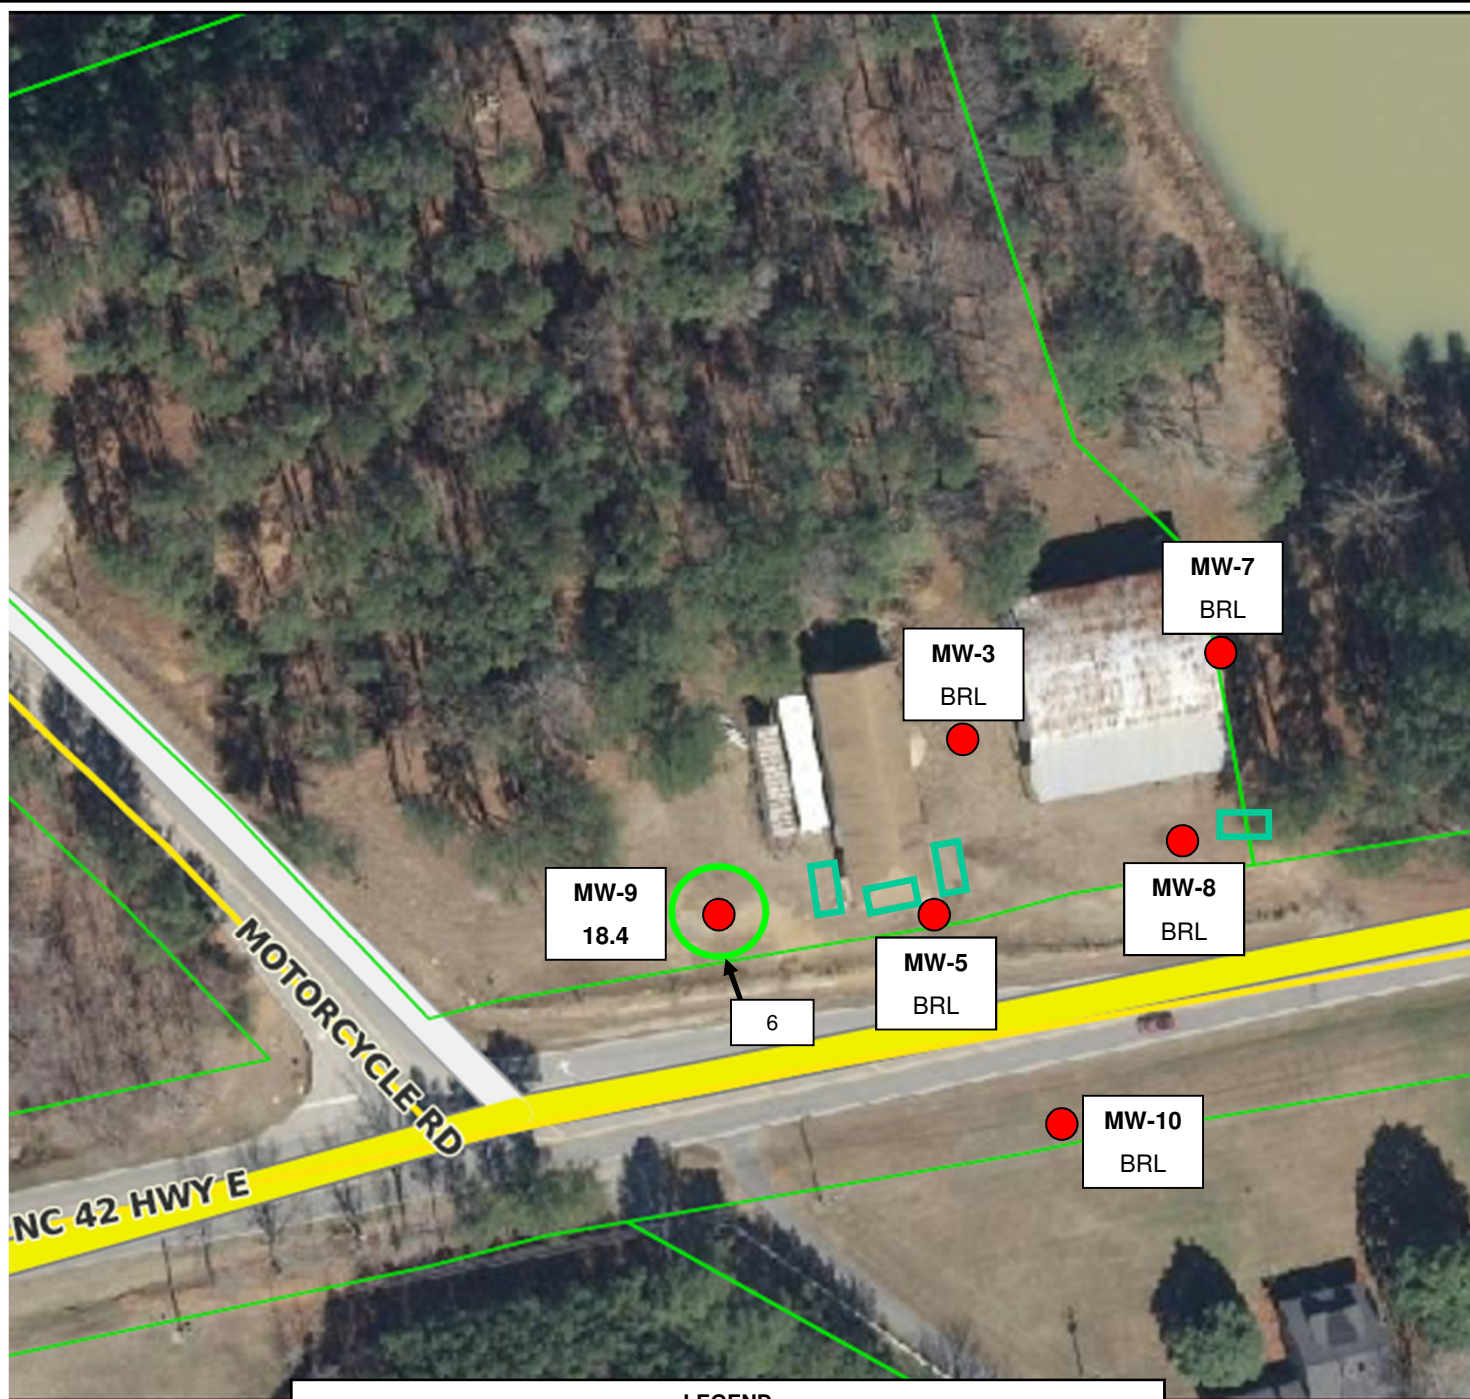
#### FIGURE 6 NAPHTHALENE ISOCONCENTRATION MAP

- MW-3** ● Approximate Location of Monitoring Well
- Naphthalene Isoconcentration Contour
- 18.4** Bold Concentrations Above NCDENR GWQS
- BRL Below Laboratory Reporting Limit

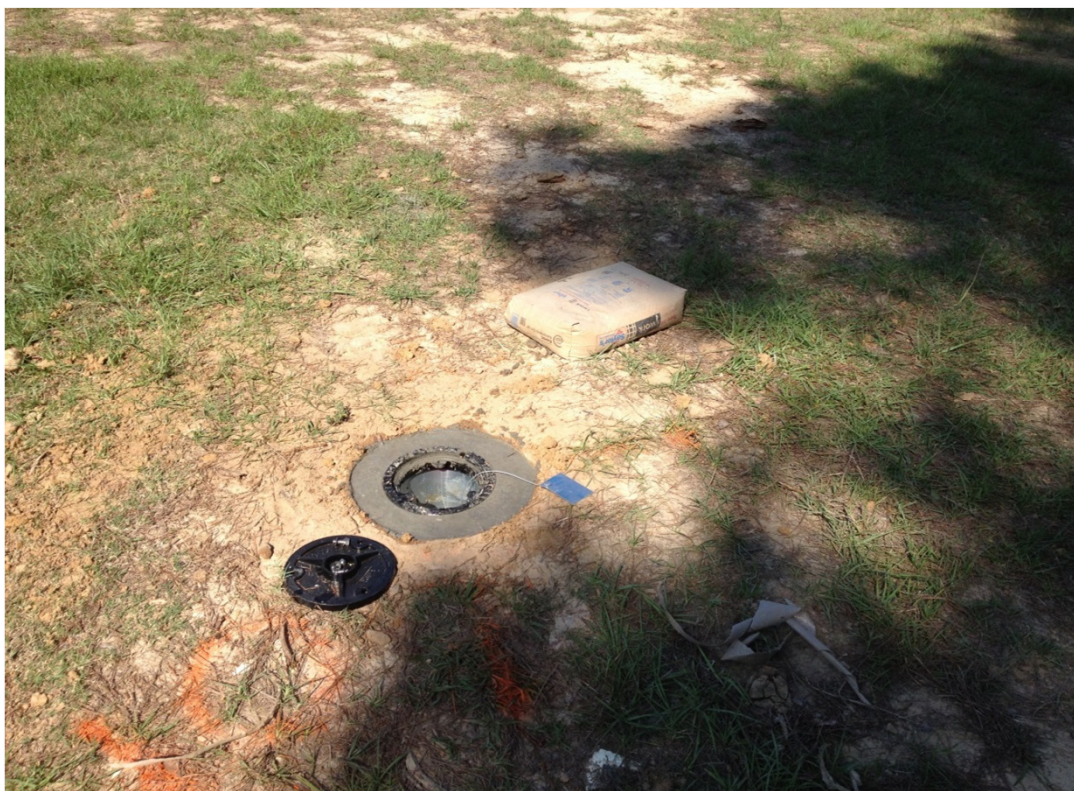
**Photograph 2: View of monitoring well MW-8**
